Much of the restoration work that the **Newport Restoration Foundation** Carpentry and Painting Crews complete is so skillfully done that it is rarely noticed by the casual visitor. All 70+ of NRF's Preservation Properties are regularly inspected for decay and rot to the exterior. A detailed document is created outlining all of the repair work needed to take place before any repairs occur. This type of detailed specialized restoration work takes time, commitment, and of course financial backing to ensure the long-term stewardship of the NRF House Collection. Rarely does a house only need a fresh coat of paint!

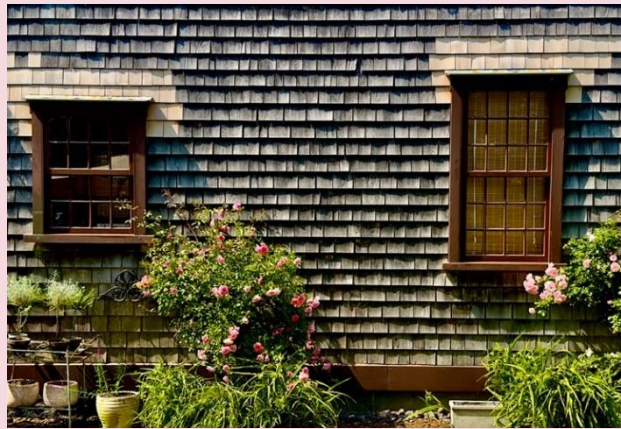
Much of the restoration work occurs in isolated, small spot repairs throughout the houses (middle photo). Often the only thing needed to repair a shingled exterior wall may be a few lines of replacement wood shingles above the windows (right photo). In other cases, selective wood clapboard replacements are expertly inserted into the existing sheathing. Once painted, the repairs become seamless. Thank you to the NRF Preservation Team **Alyssa Lozupone** (Dir. of Preservation), **Margaret Back** (Preservation Projects Manager), **Joe Chretien** (Preservation Crew Supervisor), the **NRF Carpentry and Painting Crews**, and **Erica Kelley** (Tenant Liaison).

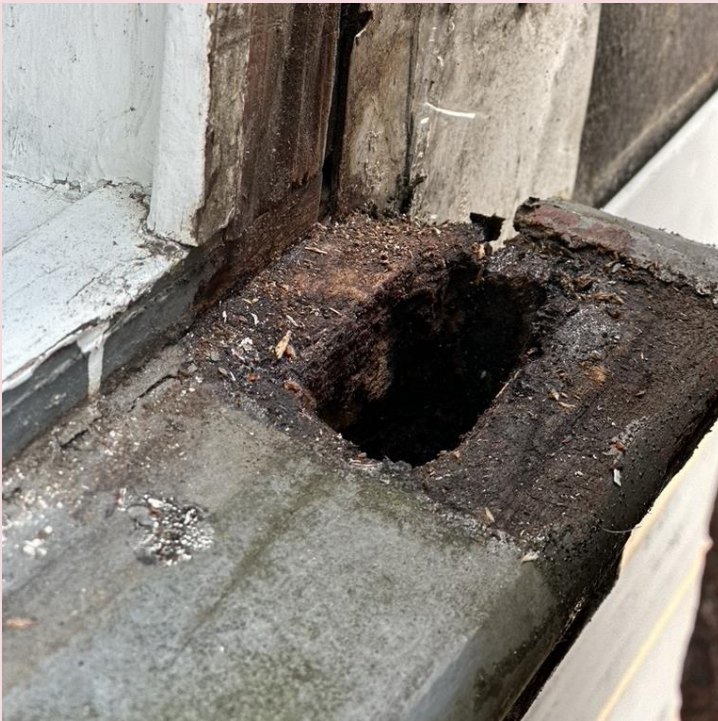
2 Marlborough Street is currently undergoing extensive exterior restoration. Deteriorated and rotted pieces are removed and replaced with new wood elements (left photo). In this example, a window jamb is removed, and the sill is cleaned out so that a new replacement, specifically milled to fit this window, can be inserted (right photo). The new window jamb is replaced seamlessly into the existing historic structure. Someone walking by and admiring the architecture of the NRF Houses might never know the extensive restoration work involved in replacing a simple wood element such as a window jamb.

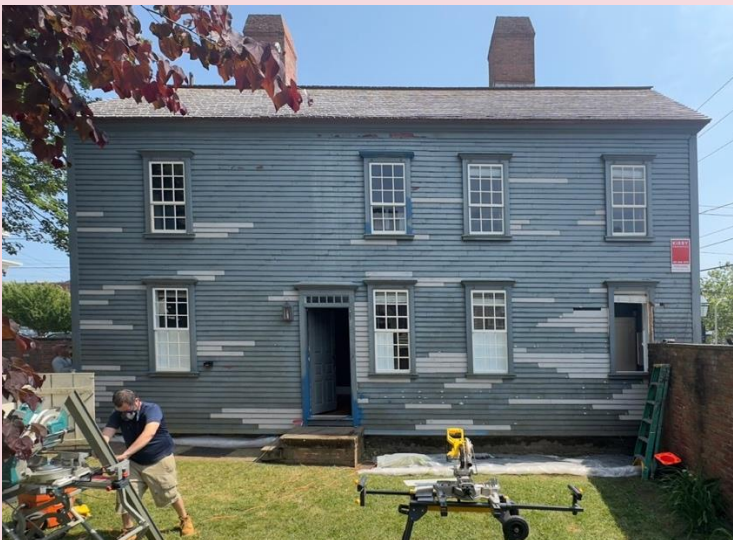
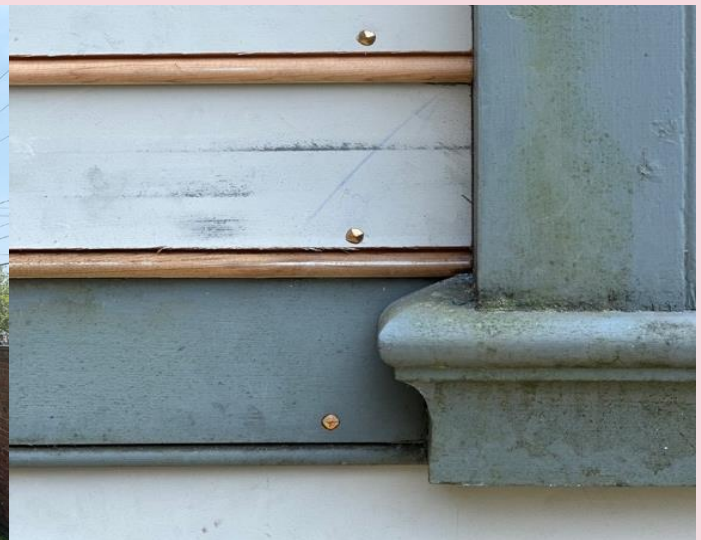
The exterior cladding of **2 Marlborough Street** has been inspected and any siding that has decayed is replaced with freshly milled clapboard. In this case, brass nails are used to reflect the historic construction of the building. Once painted, these repairs will no longer be discernable.
