The 2024 restoration activity is well underway. (middle photo) As part of our roof replacement schedule, we have begun 175 Spring Street. (right photo). The roof material dates from about 1970 and needs to be removed down to the roof structure, new water protection applied and eventual fresh wood shingles. (right photo) The existing roof at 175 Spring Street, installed around 1970, shows obvious signs of age, damage, and moss growth. Thank you to the NRF Preservation Team **Alyssa Lozupone** (Dir. Of Preservation), **Margaret Back** (Preservation Projects Manager), **Joe Chretien** (Preservation Crew Supervisor), the **NRF Carpentry and Painting Crews**, and **Erica Kelley** (Tenant Liason).

Every year Newport Restoration Foundation prioritizes the repair and restoration needs of our 71 colonial homes. The homes are primarily located throughout Newport in the **Historic Hill & The Point** historic districts. The needs of these buildings require constant long-term evaluation and reponse to any unexpected emergencies. As the 2024 season warms up, so is our restoration activity. Highlighted in this update are our re-roofing projects. Since 2019 we have been methodically replacing old

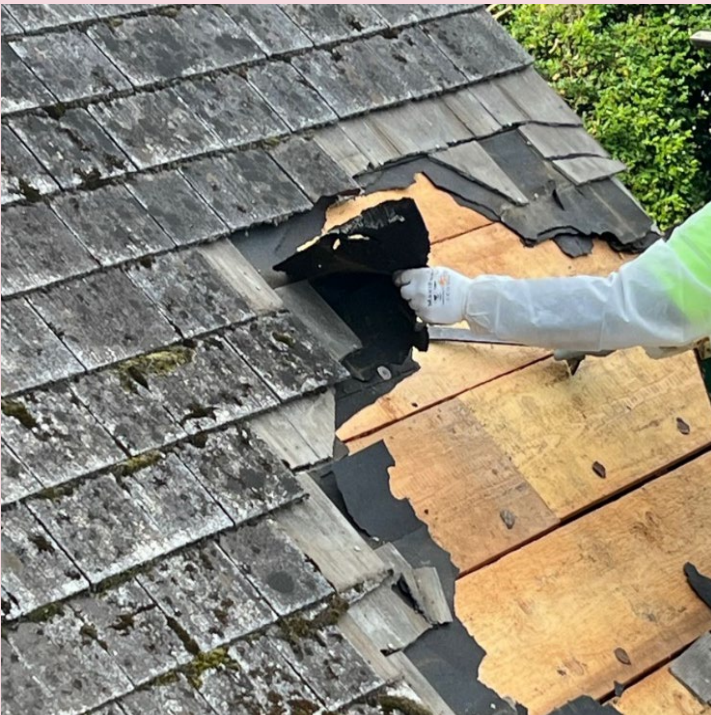
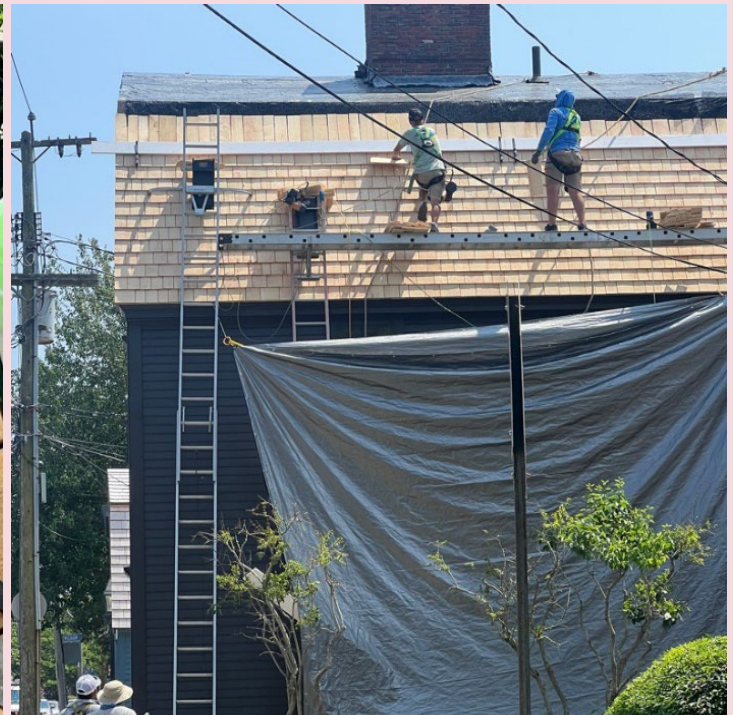
175 Spring Street is sheathed in protective plastic as the work to remove the existing roof material begins. Because of the gambrel roof structure, a hydraulic lift is required. The tight urban fabric of Newport makes this type of work difficult because there is limited space for set-up and removal of debris. Many NRF houses are zero-lot line and rest directly against the pedestrian sidewalk.

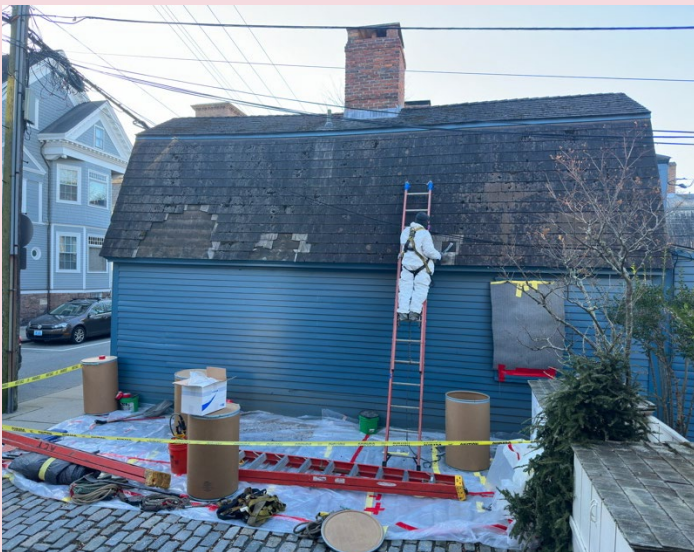
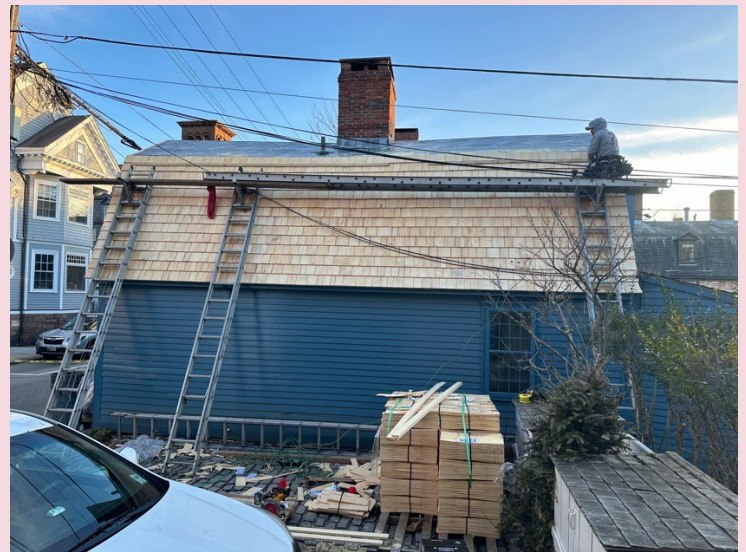
The roof on **181 Spring Street** has been completed. The process involved the removal of the previous failing cementitious shingles and foil underlayment, followed by a new water-protection system and wood shingles. The home is now ready for its next tenant-steward to move in.
